Slides, Cambers, Slumps and ‘Terraces’: Part I

This paper, and the next two to follow, form a series which will describe and illustrate Gravitational Structures in the Cotswolds, i.e. those structures which are formed by the action of gravity on the soil and/or on the underlying solid rock. Gravity becomes effective when the strength of the soil or rock is reduced, usually by an excess of pore water, or because the stability of a slope is reduced by the removal of soil and rock from the base of the slope.

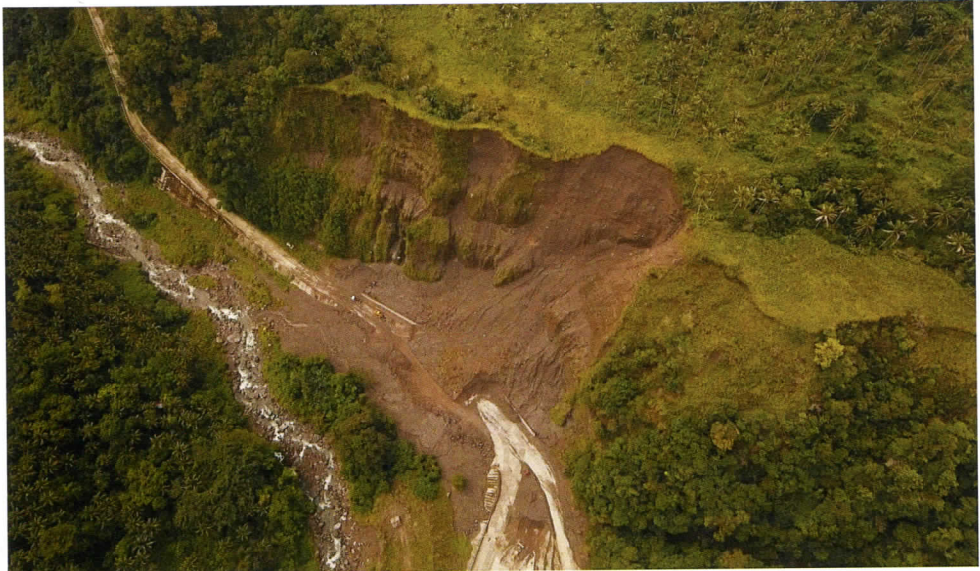
Fig 1: Simple collapse type landslide, which typically occurs where the oversteepened slope is formed of a roughly homogeneous rock type. (<https://www.geotech.hr/en/landslide>)

Landslides occur due to the failure and collapse of a steep slope. This failure can either occur as a wholesale collapse of the rock face (Fig. 1)

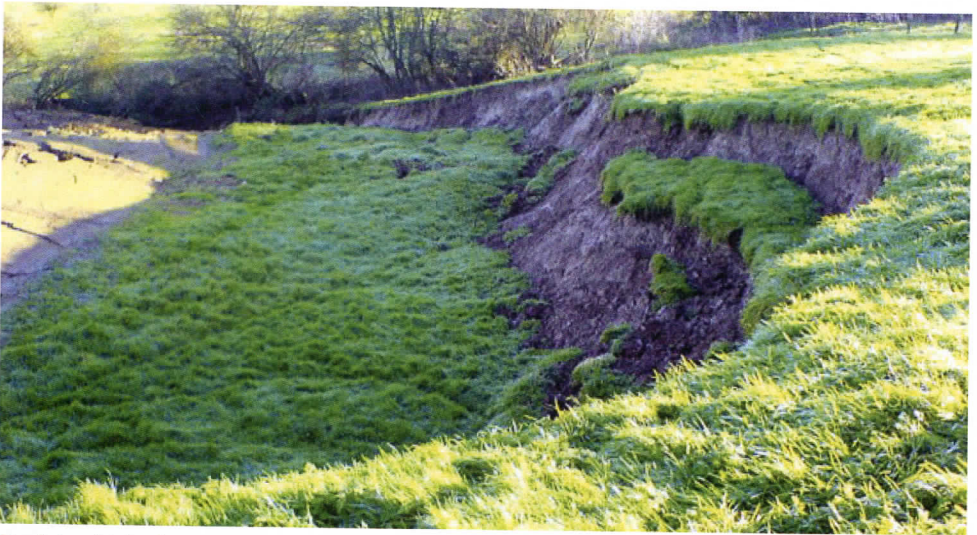
Fig. 4: Landslide above the Windrush valley (Dec. 2006), south of Bourton on the Water. Height of the arcuate head scar ~3m. For location see Figs. 5,6.

By contrast, a smaller, but still significant landslide occurred in December 2006 just south of Bourton on the Water, on the West flank of the Windrush valley (Figs. 4, 5, 6). Of interest is the fact that the difference in slope between the slipped mass and the undisturbed hillside above it shows that the slipped mass has back-rotated towards the slip face.

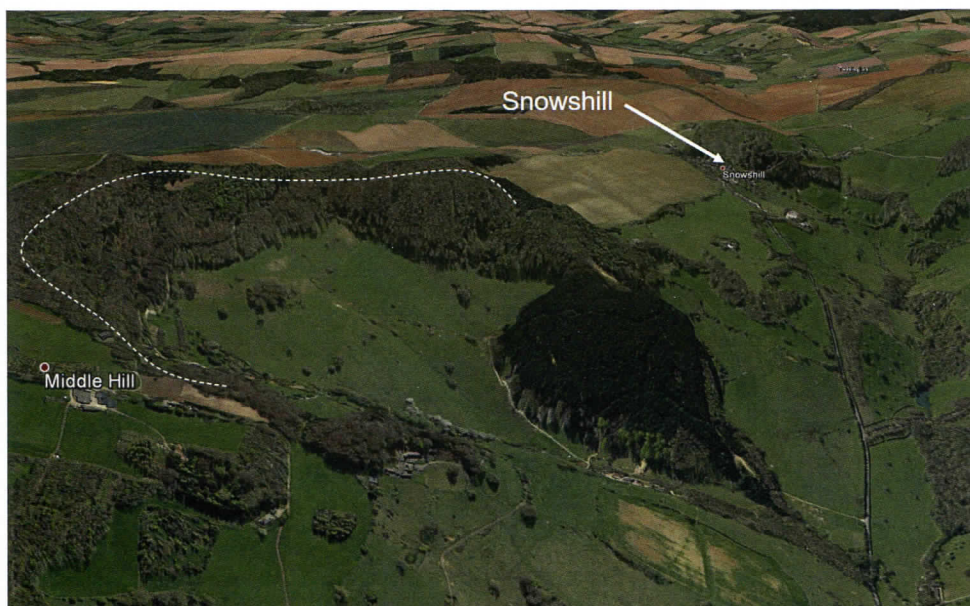
Fig. 3: Google Earth view of a possible landslide on the east side of the valley between Broadway and Snowhill, looking South. The white dashed line highlights the arcuate scarp or slip face, whilst Dulverton Wood (the forested hump in the middle of the slope) could be a block of oolitic limestone detached from the crest of the scarp. The slip face is ~1 km in diameter.

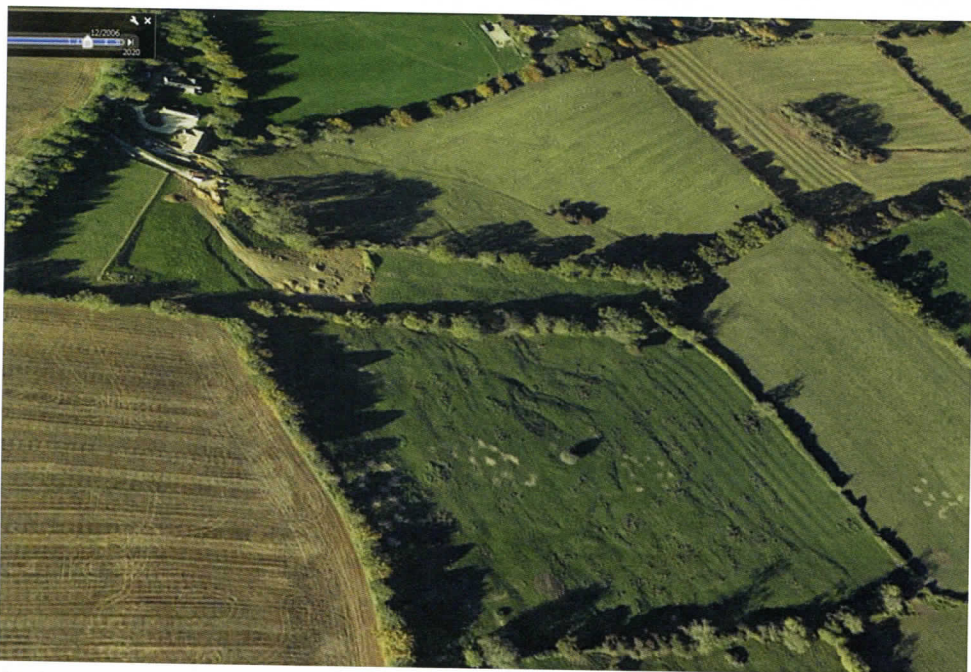
Fig. 6: Arcuate slumps and landslips obscuring Medieval ridge and furrow field patterns, now only visible at the bottom of the field. This shows that the process of slope collapse has been ongoing for hundreds of years. The immediately adjacent field is the location of the 2006 landslide (Fig. 4). View is to the NW.

Evidence for this landslide has now been removed by the landowner's re-grading of the slope, but the adjacent field clearly shows evidence of long-term landsliding, which can be dated as post-Medieval because the terminal mudflows have buried Ridge and Furrow field patterns, now only visible at the base of the slope (Fig. 6).

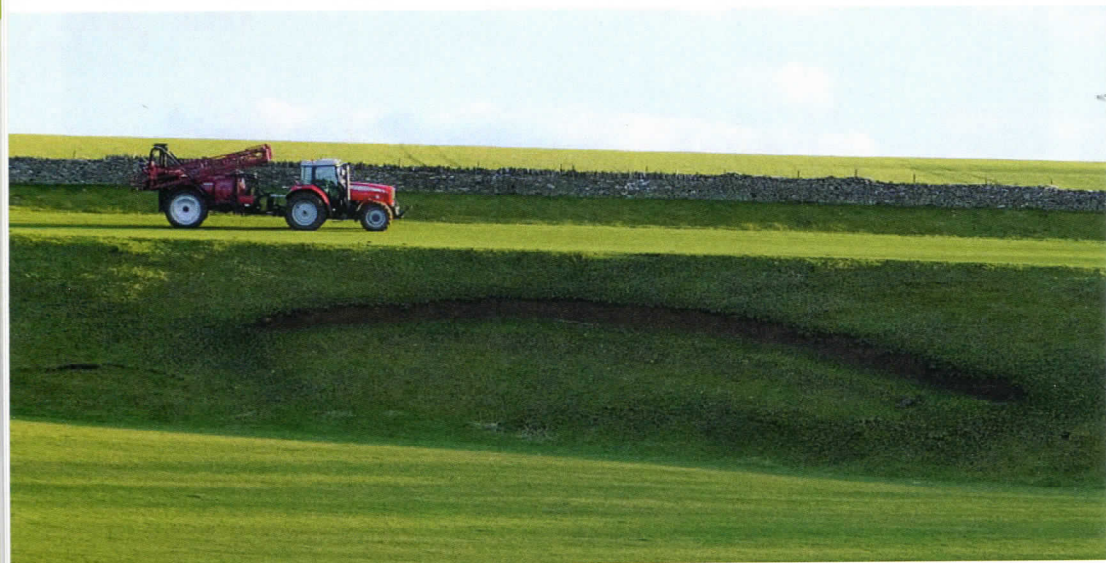
Fig. 7: Hawling mini-landslip, with tractor for scale.

Finally, a small landslide located in a field just East of Hawling (GR 072231), and recognised by its arcuate shape, is probably only a year or two old, based on the freshness of the slip face (Fig. 7).
